RAM 2500 58522 ADAPTER KIT FOR 30035 (Page 1) & 30095 (Page 2) KIT

2014-CURRENT RAM 2500 (REQUIRES 58522 BRACKET KIT)

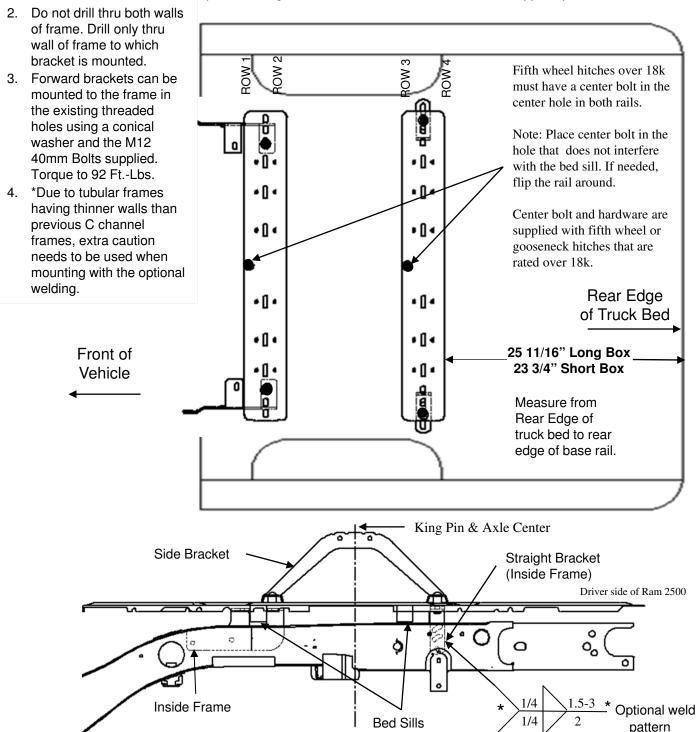
1. Rib neck bolts will need to be pulled through rearward access holes in frame with supplied pull wire.
